# AeroMACS Verification Plan & Report - Phase 2

Project Title	Airport Surface Datalink
Project Number	15.02.07
Project Manager	INDRA
Deliverable Name	AeroMACS Verification Plan & Report - Phase 2
Deliverable ID	D10
Edition	00.03.00
Template Version	03.00.00

The general purpose of the 15.02.07 is to verify the AeroMACS Data Link. This document describes the verification plan applied within the 15.02.07 Project for phase 2 testing and the corresponding tests report.

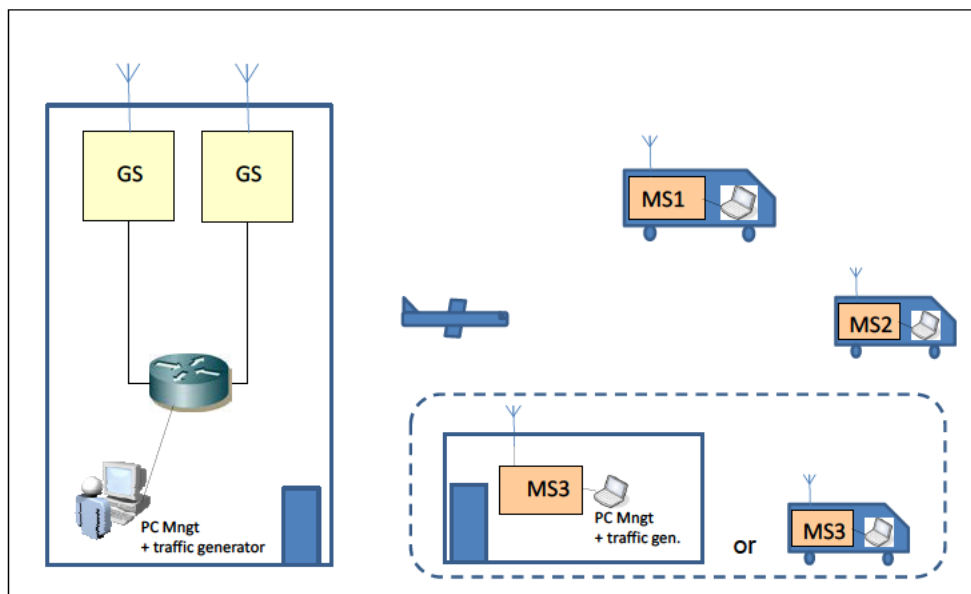
Figure 3-3 : Thales-DSNA airport ground test configuration

Two MS are installed on vehicles which are moving in different airport areas at different speeds and collect measurements regarding different propagation conditions. One MS is located on a fix place.

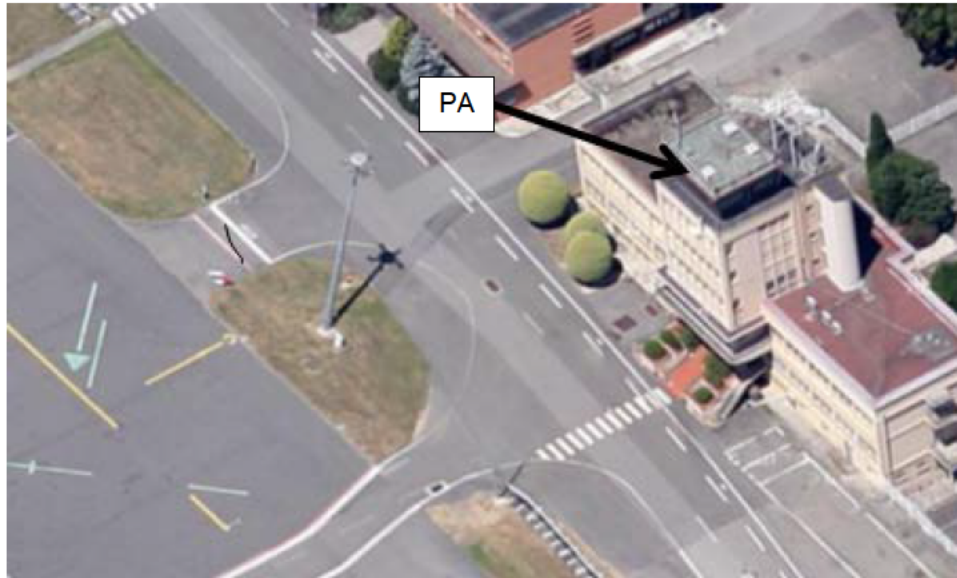
Figure 3-5: General view of the former control tower

The Ground Stations are installed on the former control tower represented on picture below (PA position, lat. 43.623078, long. 1.380049).

The two BS are installed on the roof. The working position with the IT devices (PCs, PoE injectors, switch) are installed on the top room of the control power. The connection to the GS is achieved via Ethernet cables.

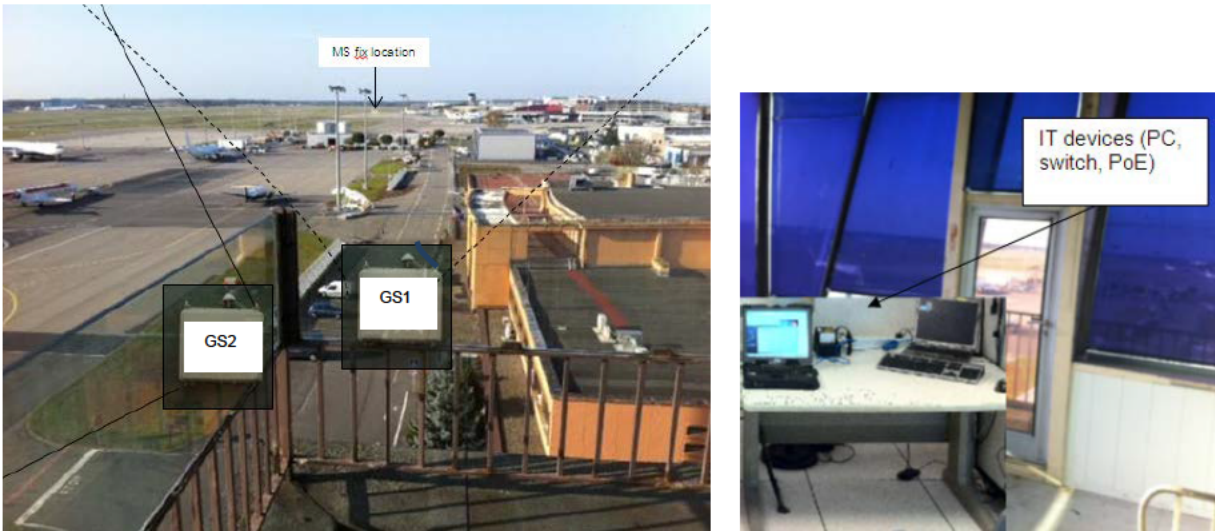
Figure 3-7: Roof situation on the left – Working position on the right

Each GS is oriented to make the best coverage of the airport with an optimized overlapping zone. From the GS on the roof, an Ethernet cable will come from the GS to the control tower upper room where IT devices will be installed as represented on following picture. All necessary means to accommodate the IT devices and the people are to be provisioned by DSNA (e.g. table, chairs and 230 V AC power supply).

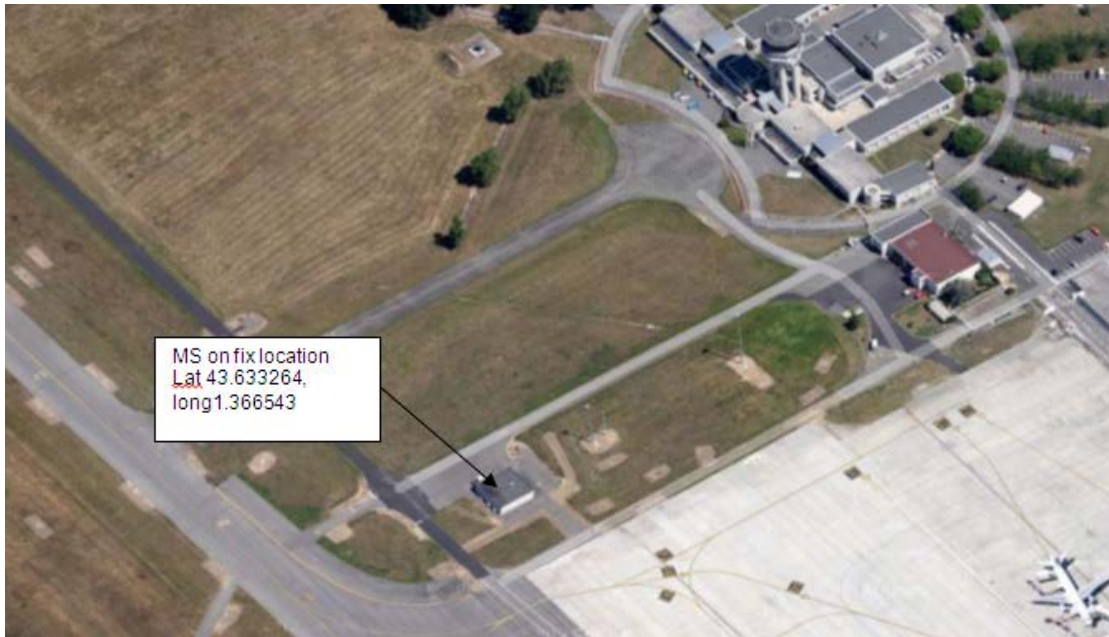
Figure 3-11: fix MS location

The fixed MS is located on a DSNA building near position PB on above map.

The MS and the antenna are setup on the roof and an Ethernet cable is coming down to the working position as depicted in following picture.

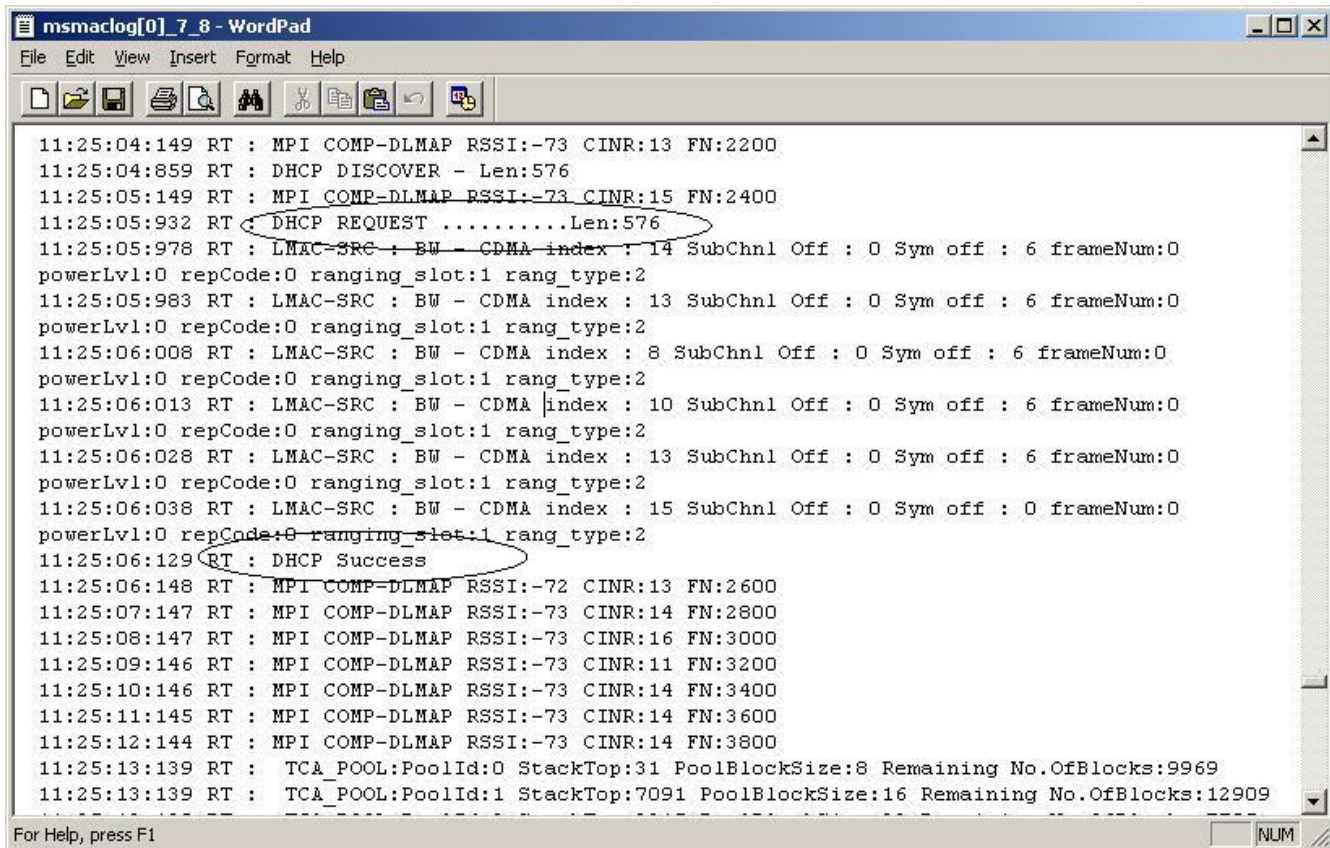
As a test preamble, the various phases of the normal Initial Network Entry was executed by BS and MS (test step no. 6). Figure 7-1 shows the last step (MS DHCP Registration),

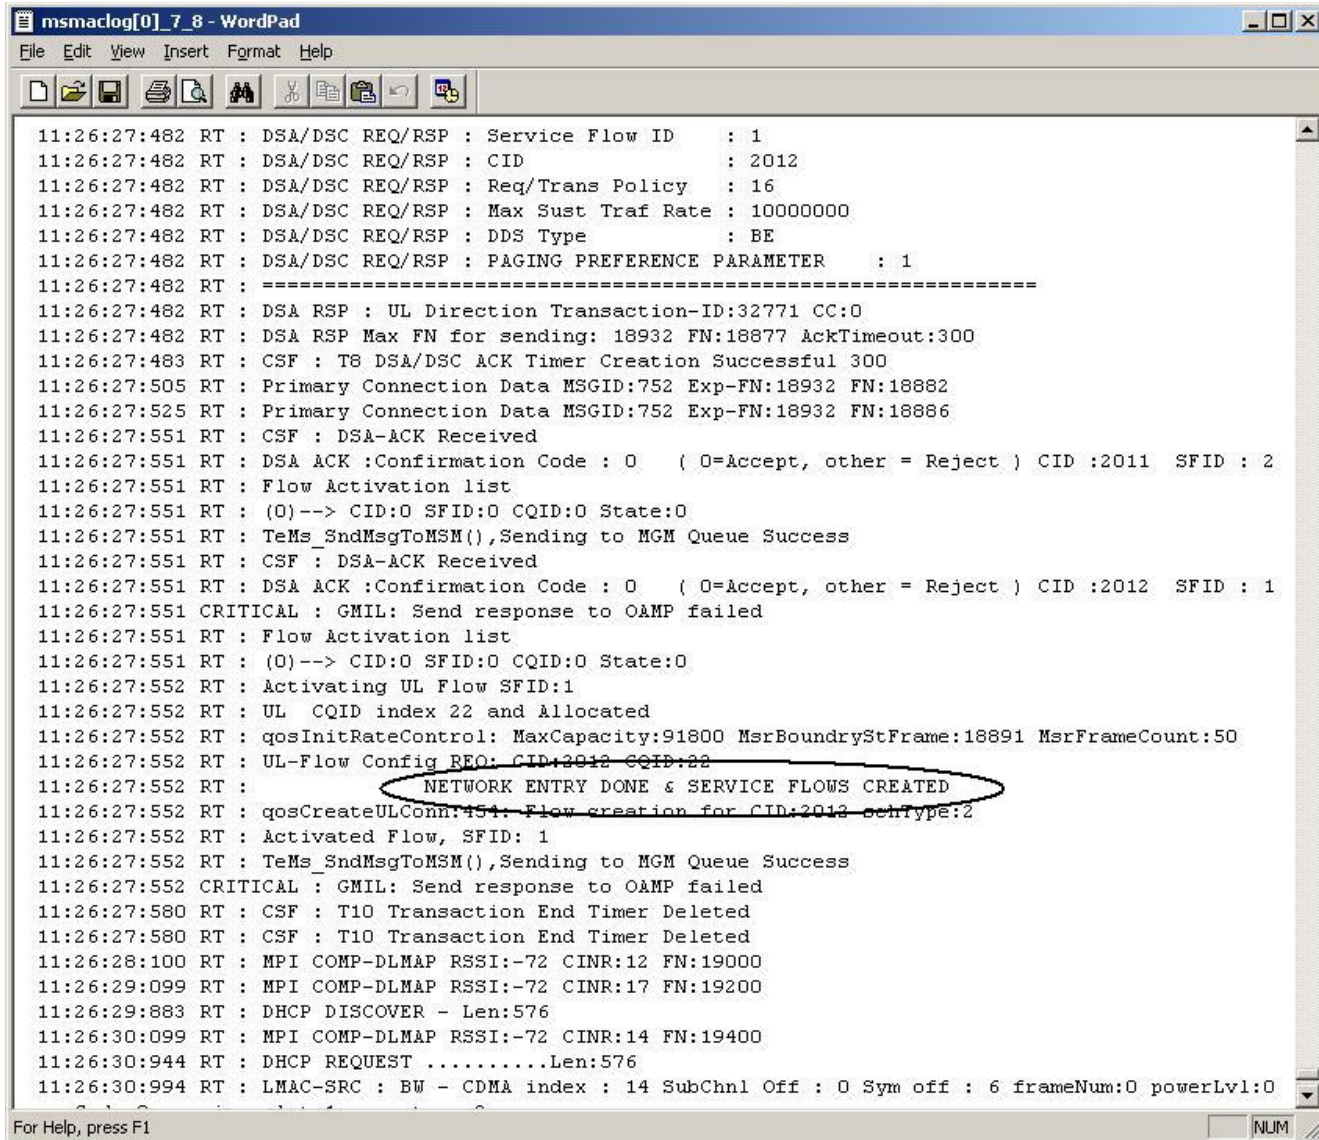
Subsequently, the attenuation between MS and BS was gradually decreased, until the MS correctly repeated the Network Entry (Figure 7-3).

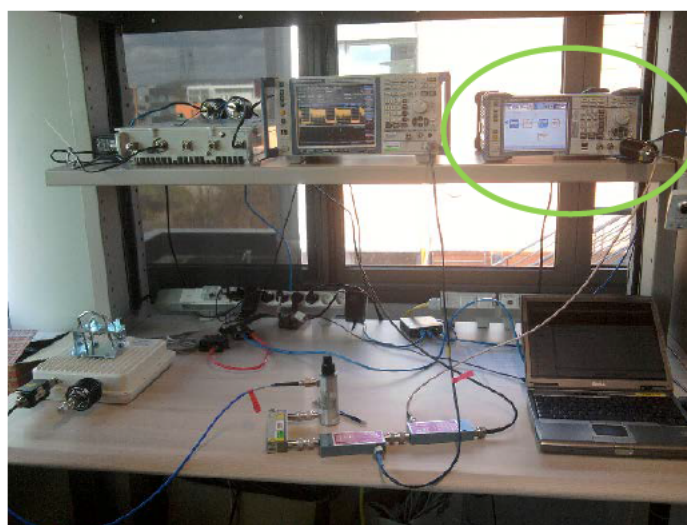
Figure 7-22: test bed configuration with a signal generator

Lab-test\_bed\_01 is prepared with an additional signal generator to simulate the interfering signal on adjacent and alternate channel.

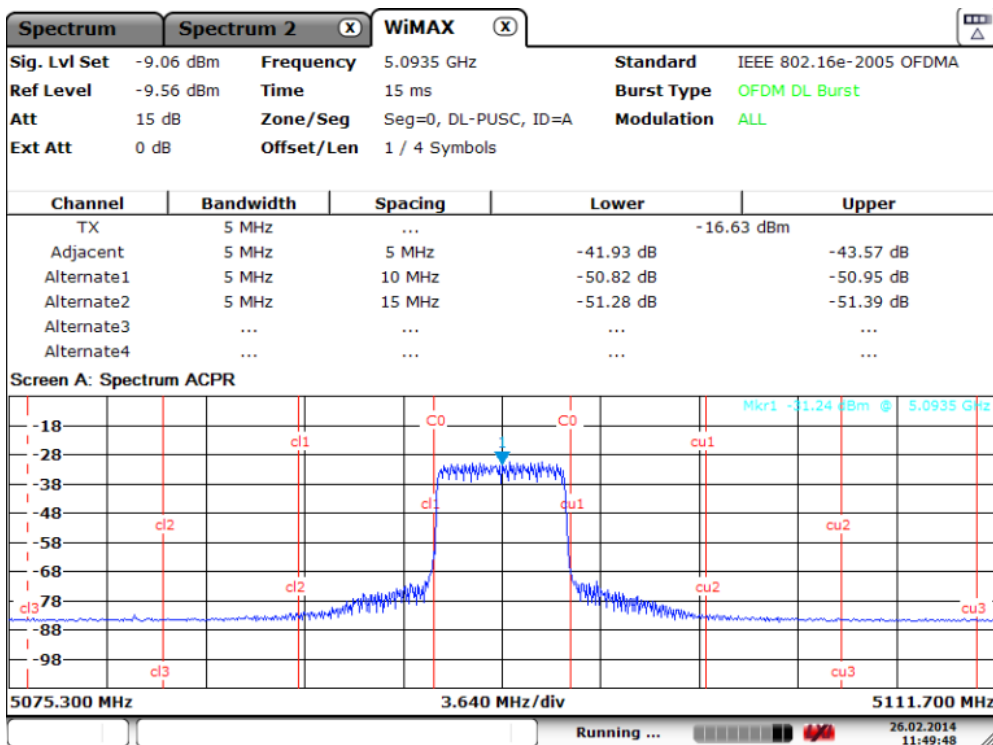
Below we see the result for the DL (values expressed in difference compared to central channel (TX)):

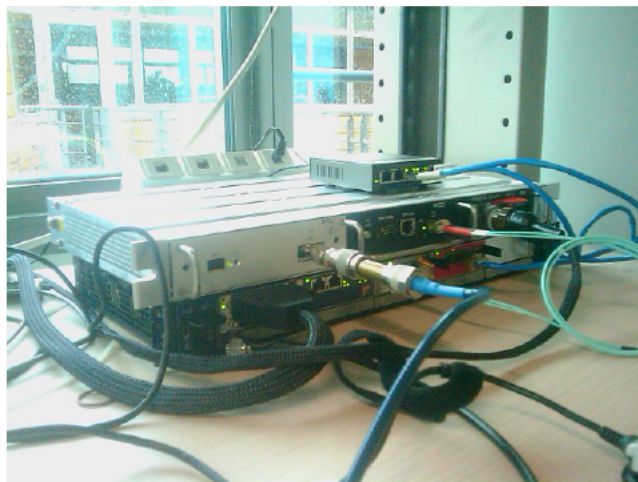
Figure 7-23: Selex MS in Thales lab (Baseband 1U rack below and RF 1U rack above)

Lab-test\_bed\_01 is prepared.  
 Selex MS replaced Thales MS.

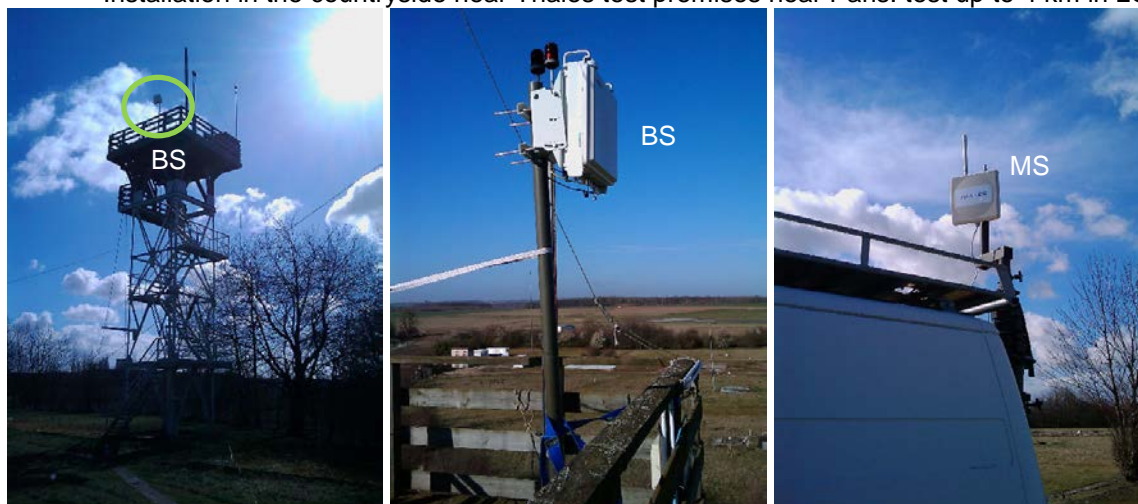
Figure 7-26: Setup of the BS on a tower and MS on a truck for outdoor tests

- Installation in the countryside near Thales test premises near Paris: test up to 4 km in LOS.

- Installation in Thales premises Gennevilliers: test in NLOS and mobility, registration to the two base stations. Furthermore, the testing software that records positions along with MS measurements (called survey tool) was also verified.

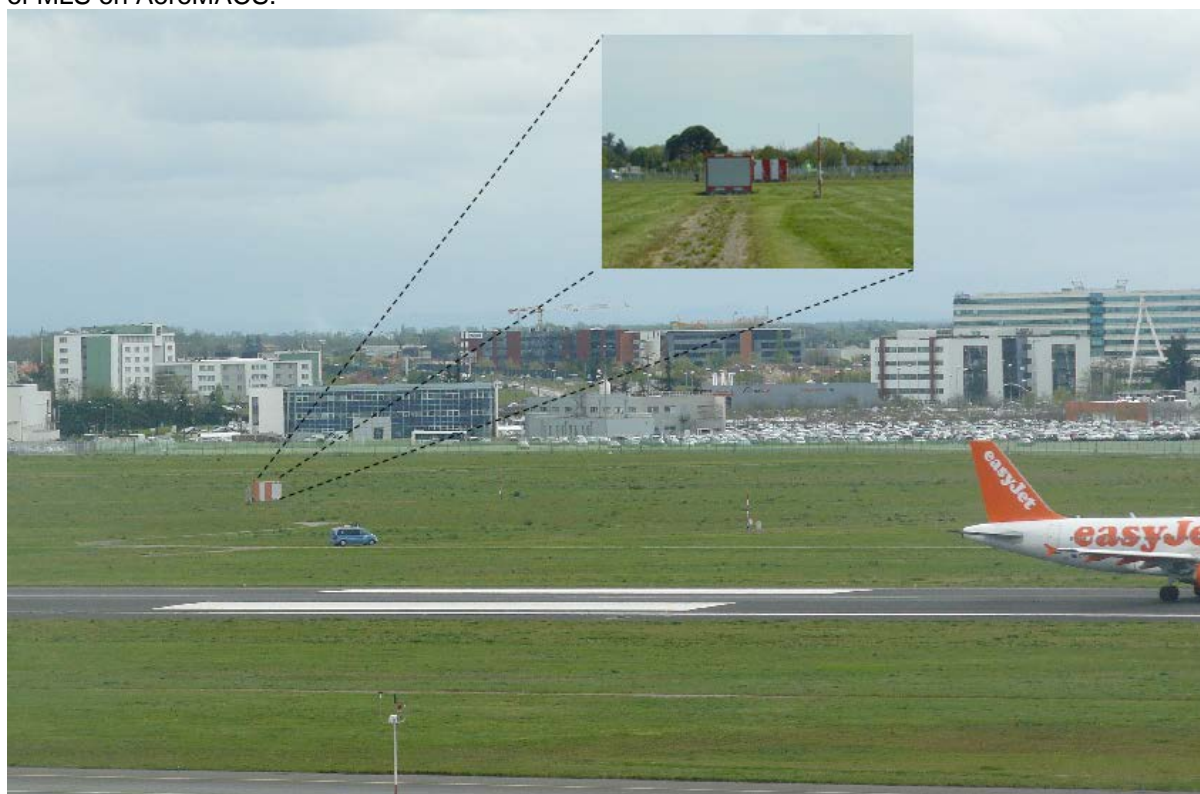
**Figure 7-37: MLS (south) test location**

Some measurements were made nearby the MLS (see picture below) in Toulouse to see the impact of MLS on AeroMACS.

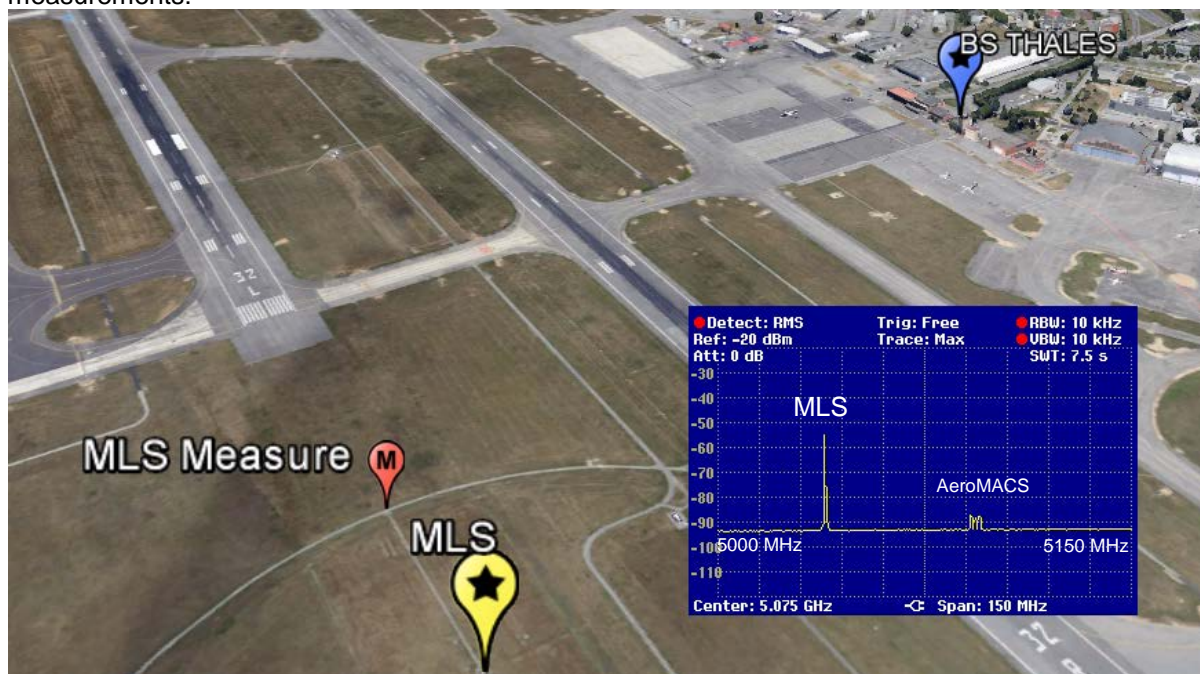
Figure 7-41: Spectrum measurement near MLS signal (south)

Concerning other potential sources of interferences, note that no AMT and no other AeroMACS system signals were detected on the Airport during our field trials. Below the spectrum measurements:

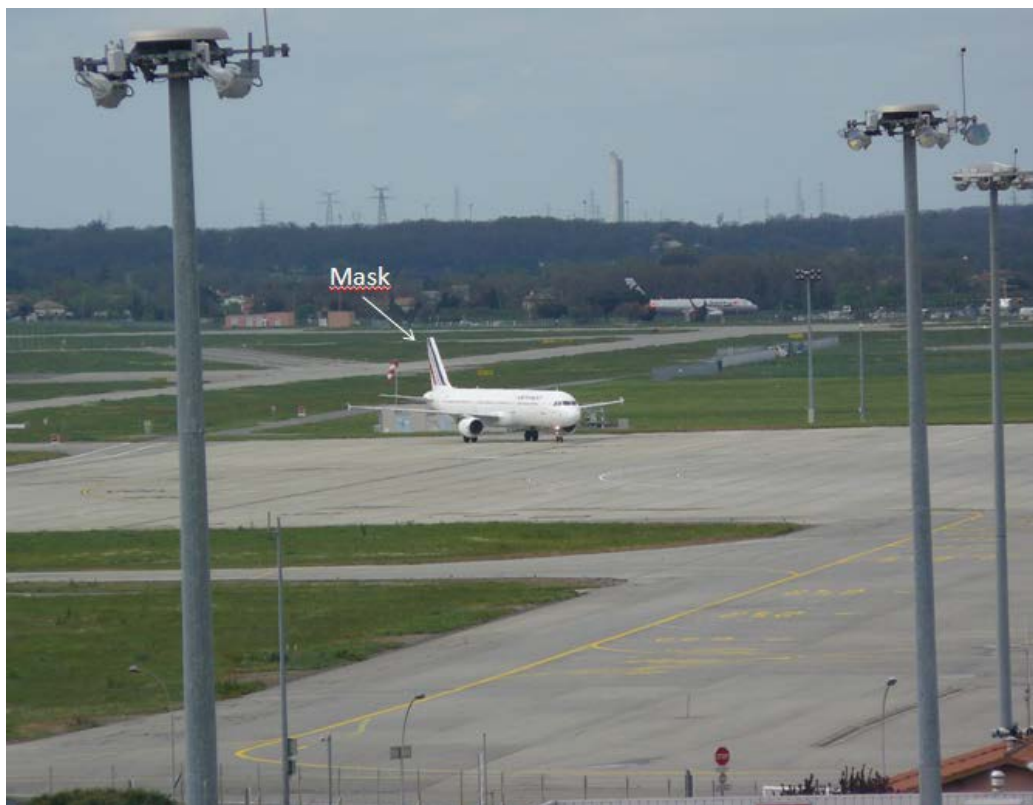
**Figure 7-43: Mask due to aircraft which hide the antenna on PB**

The fix MS at PB is most of the time in line of sight with the BS. In fact, as it is located near the terminal area, it happens that the aircrafts drives close to PB and generates a mask between the MS antenna and the BS antenna (as one can see on the picture below taken from the BS location). The corresponding RSSI degradation was between 10 to 15 dB.

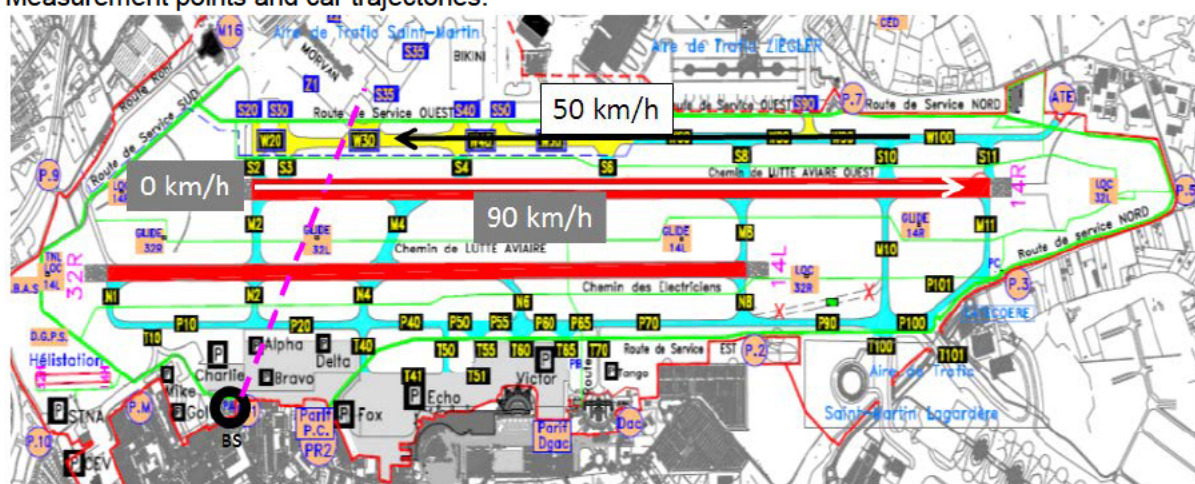
Measurement points and car trajectories:
